Inspection Report

Property Address:
#123 - 456 Sample Street
New Westminister BC V3M6B9

Fairbairn Inspection Services

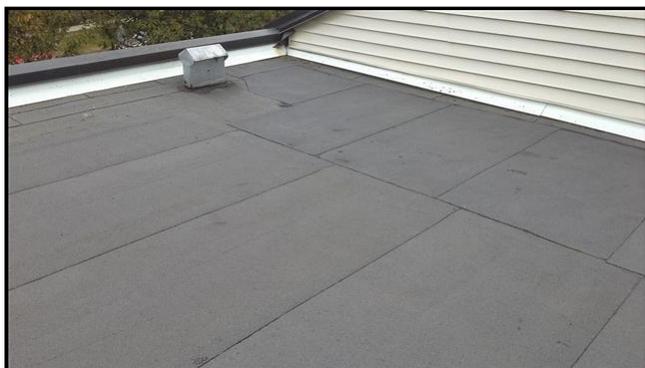
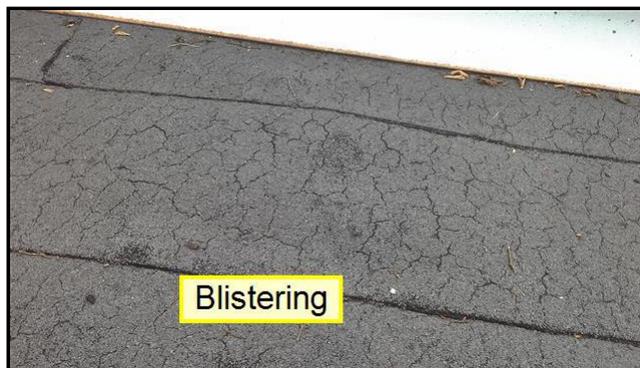
1.0

- The roof was covered with a "torch-on" modified bitumen (SBS) roof material. The number of ply (layers) was unknown.

Prior repairs were noted in multiple locations around the roof. Prior failure/leakage may have occurred in these areas. Multiple blisters were also noted, and the roof is near the end of its service life. I recommend budgeting for repair / replacement within 1-3 years.

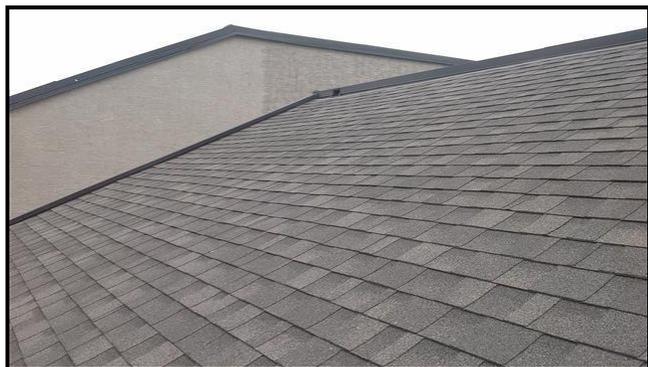
1.0

- The sloped roof was covered with laminated composition asphalt shingles which were each composed of multiple layers bonded together. Shingles with multiple layers bonded together are usually more durable than shingles composed of a single layer.

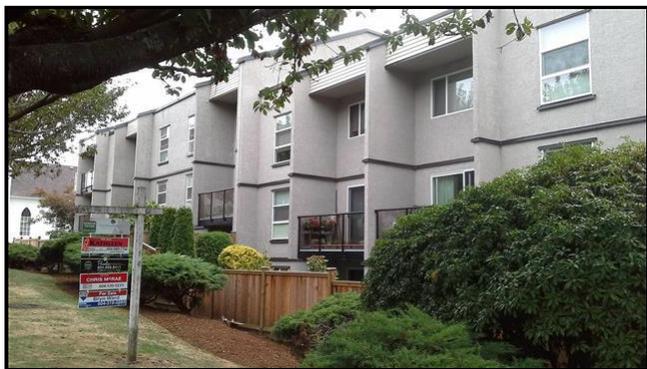
2.0

🔍 The exterior cladding consisted of cement stucco. A rainscreen assembly appears to be installed. This is considered a low-risk design for leakage problems.

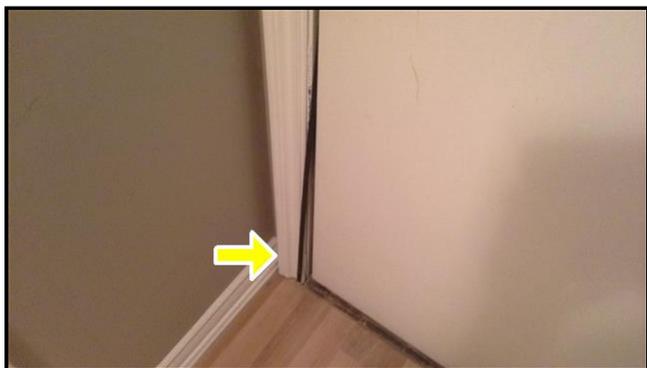
2.1

🏠 The broken weather stripping at the door should be repaired.

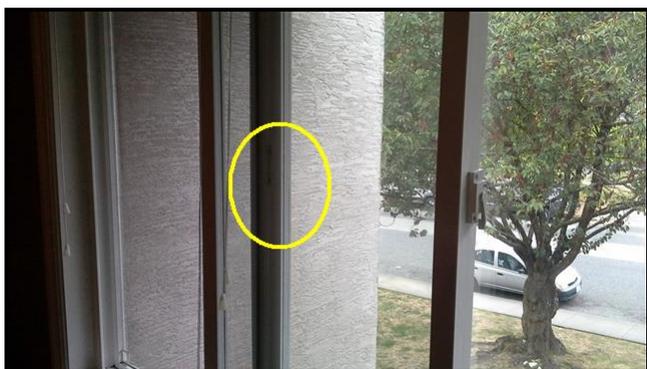
2.2

🏠 The living room window could not be locked. I recommend repairing the hardware.

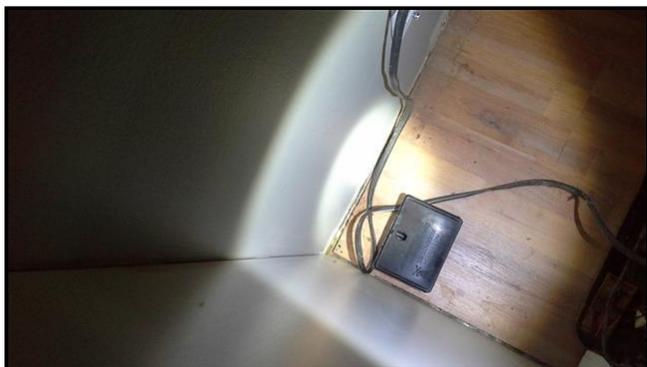
4.1

A mouse trap was found behind the fridge. Recommend investigating any pest activity in the home.

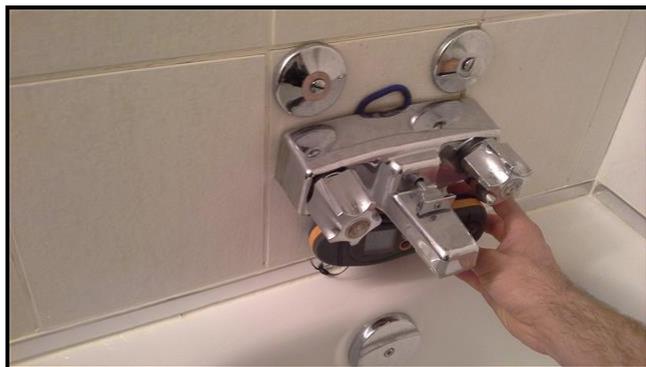
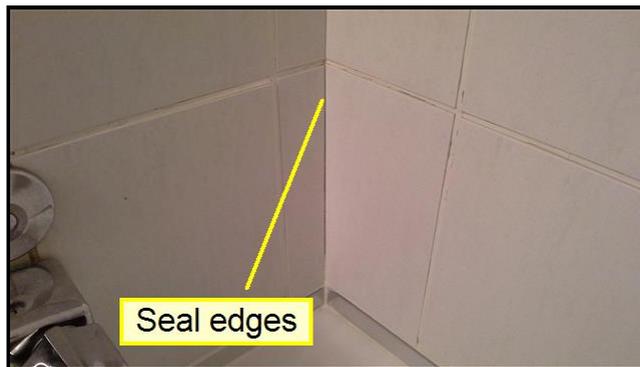
5.2

There is water leaking behind the tiles below the shower faucet. Recommend re-grouting all cracked areas, and sealing the edges.

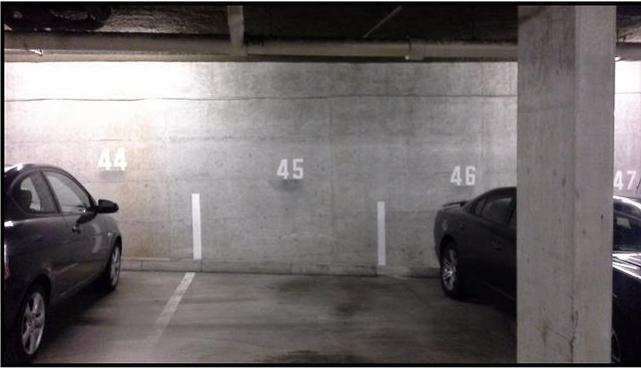
6.0

Info: The unit's parking stall was inspected with no problems noted.

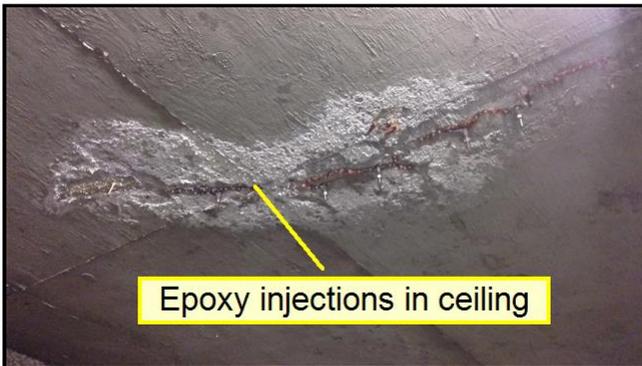
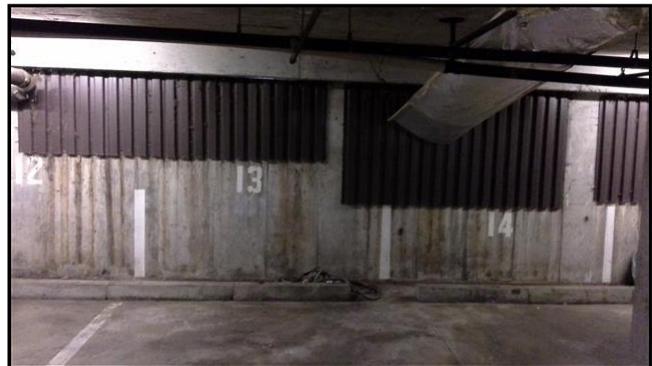
6.0

Moisture stains were seen in several areas of the parkade. Efflorescence (white stains) are common in parking garages, particularly around settlement cracks. The stains should be monitored and, if water leakage is noted, a drainage contractor should be called for further evaluation by the strata.

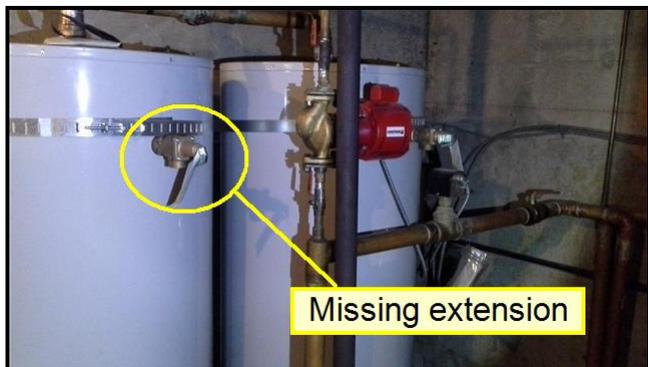
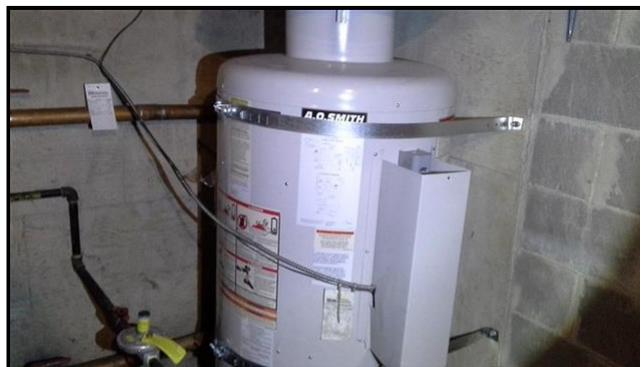
7.1

- The hot water tanks / boiler were determined to be approximately 4 years old. Average service life on these systems is approximately 10-15 years.

The units was in good working condition at time of inspection.

It was noted that the relief valves were missing extension piping, which is a safety hazard.

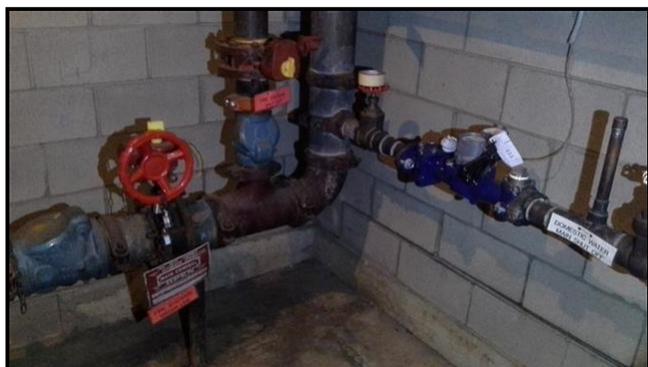
7.2

The water entry room and sprinkler equipment was inspected with no defects noted.

The unit water shut off valve(s) could not be located. Client strongly advised to confirm the location with the seller.

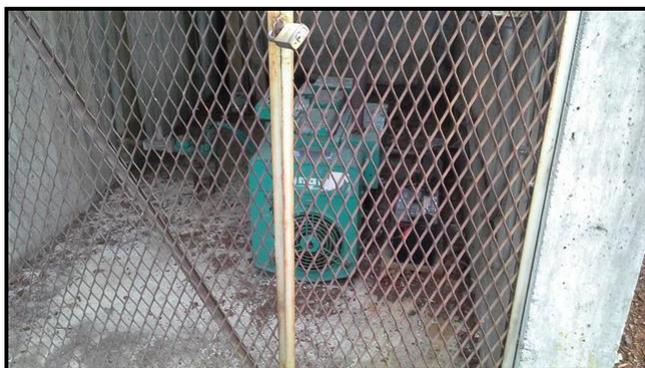
8.1

🔍 The emergency generator powers the elevators and some common area lights. It is fueled by natural gas.

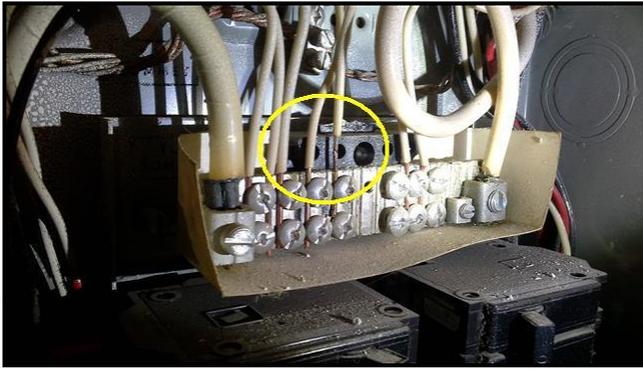
8.1

🔧 Signs of overheating were noted in the main panel, on one neutral conductor. Recommend replacement of the damaged section of wire.

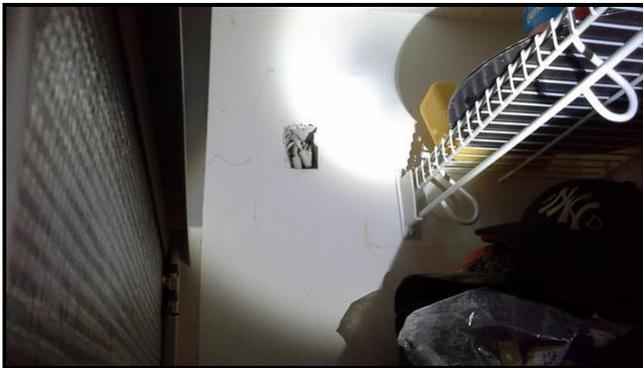
8.3

⚡ One junction box was uncovered. Uncovered outlets present a safety hazard as someone may reach in and touch exposed conductors. A cover should be installed.

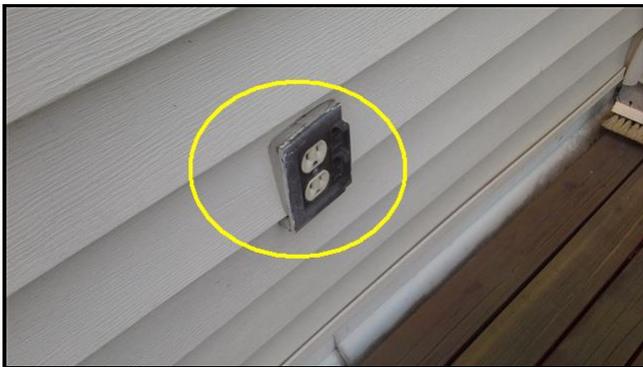
8.3

🏠 One exterior outlet was broken, and should be replaced.

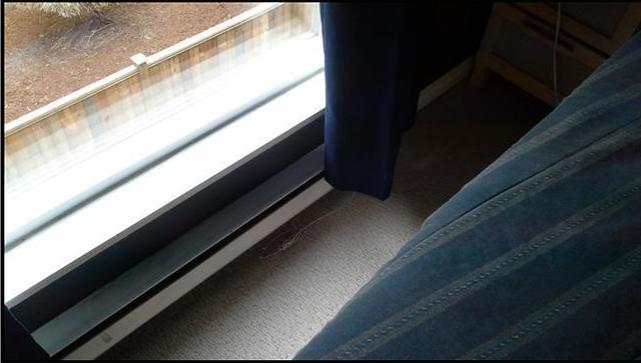
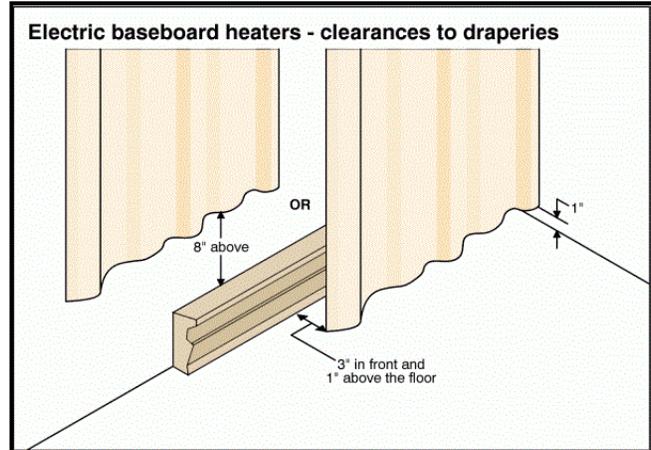
9.3

- ⚠️ Drapes were in contact with the electric baseboard heater, which presents a possible fire hazard. The drapes should be moved/changed.

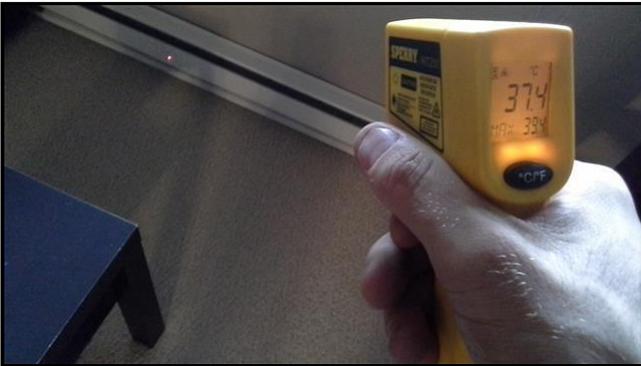
9.3

- 🔍 Confirmed working condition of the baseboard heaters in all rooms.
