# Inspection Report

**Property Address:**  
123 Sample St  
Vancouver BC V3M6B9

Pre-purchase Home Inspection

### Fairbairn Inspection Services, Ltd

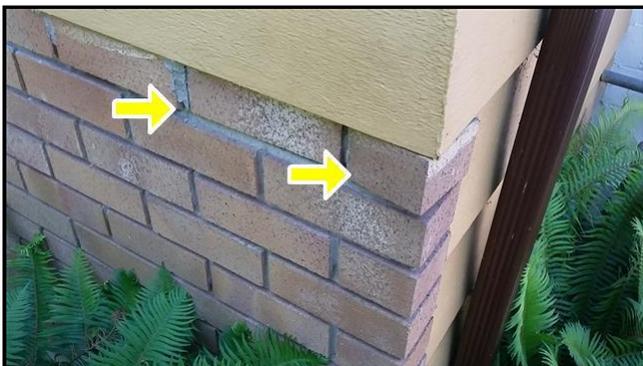
#### 1.0 Wall Cladding, Flashing and Trim

- There are several loose/damaged bricks at the front wall. Recommend having a contractor repair or replace.

1. There are several loose/damaged bricks at the front wall. Recommend having a contractor repair or replace.

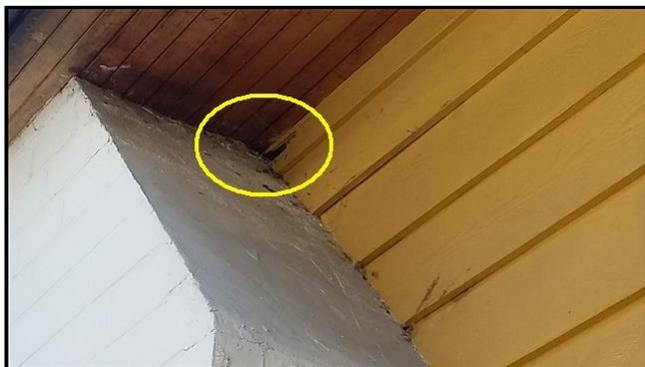
🔧 There is one small area of deteriorated wood below the chimney - recommend patching to prevent pest entry.

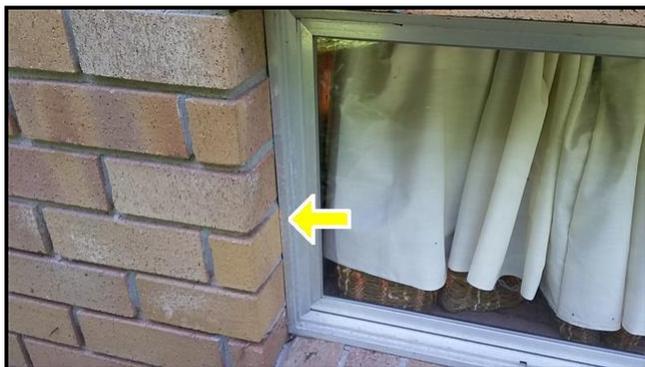
**1.2 Windows**

📍 Maintenance: Recommend caulking around the edges of the windows to prevent moisture leakage.

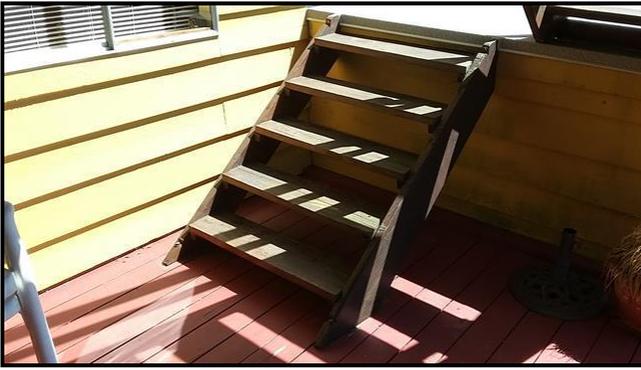
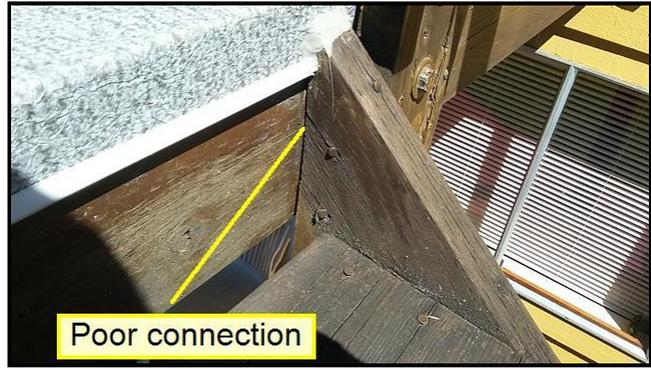
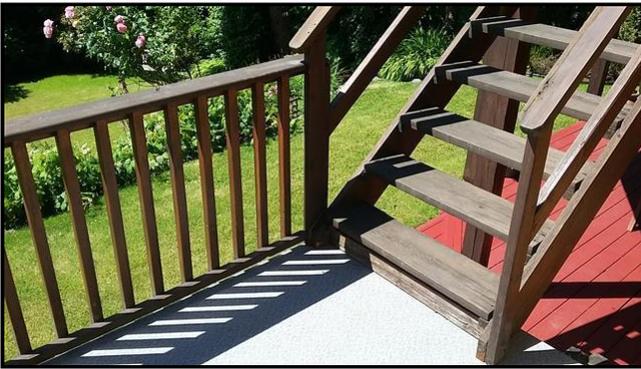
**1.3 Decks, Balconies, Balconies, Stoops, Steps, Areaways, Porches, Patio/Cover and Applicable Railings**

🔧 The rear deck should be upgraded for safety:

Loose handrails should be tightened

The stair treads are loose in some areas

The stair connection to deck is poor and may pull loose

Recommend having a professional carpenter repair as needed.

Loose handrails should be tightened

2. The stair treads are loose in some areas

The stair connection to deck is poor and may pull loose

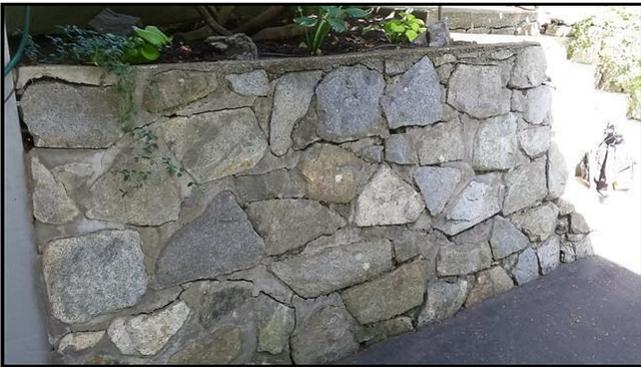
- i** There is some light cracking at the retaining walls - this is normal for the age. If the walls further deteriorate they will need eventual rebuilding.

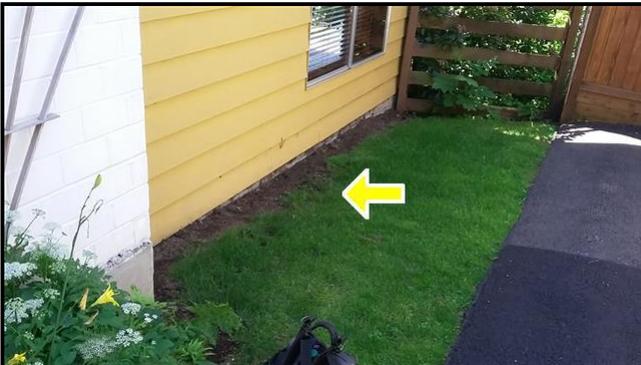
- i** There is a negative slope at the right side (facing front). Poor grading can cause or contribute to water intrusion or deterioration. I recommend correcting landscape to drain water away from home.

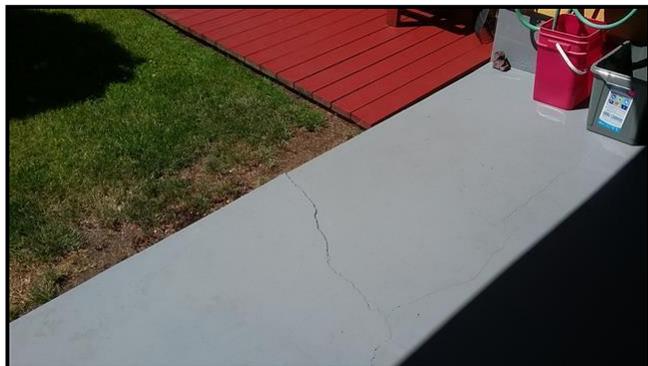
- i** The carport concrete slab is cracked and has settled. This does not appear to be structural and is likely due to the age of the home. If further settlement occurs, a concrete contractor should be called for raising/rebuilding.

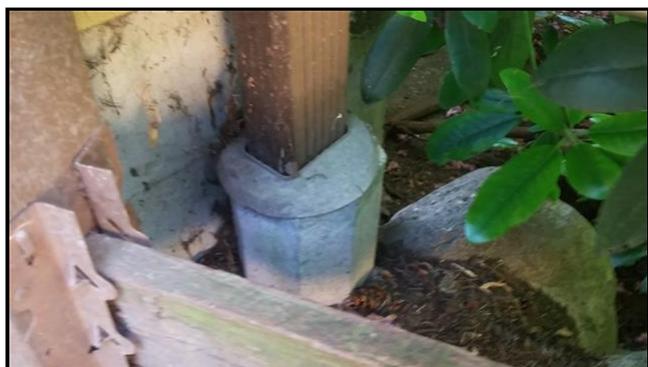
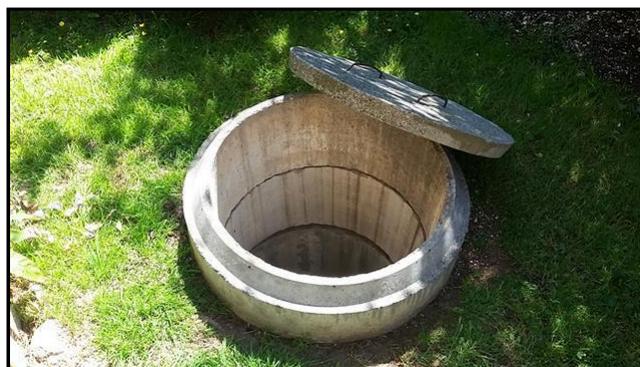
### 1.6 Storm and Sanitary Drainage, Perimeter Drains and Sump/Storm Equipment (Only visible areas from above grade)

- i** The perimeter storm drains appear to be made of concrete. This material should be cleaned (hydro-jetted) every three to five years in order to ensure performance. (Note: The buried drains are not visible and a sewer camera inspection is the only way to determine the condition)

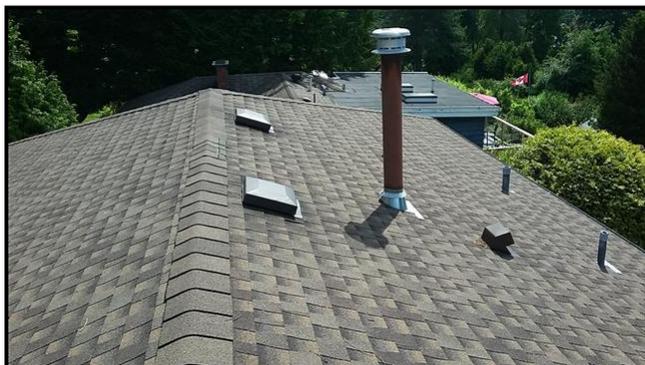
### 2.0 Roof Coverings

- The roof was covered with laminate fibreglass shingles, which are composed of multiple layers bonded together.

Estimated age is 5 years, and typical service life of this product is about 20-25 years.

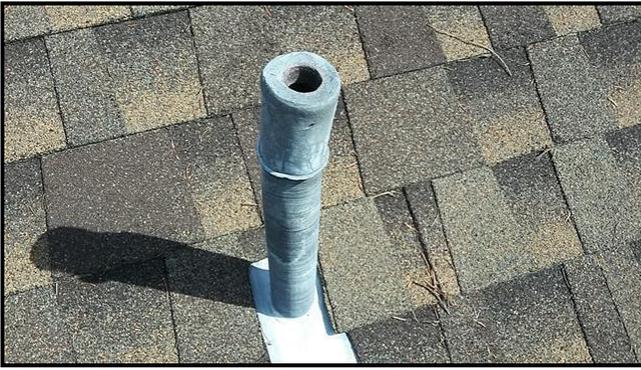
- One vent flashing cap at the rear of roof does not sit snug on the pipe and may allow water entry. Recommend adjustment.

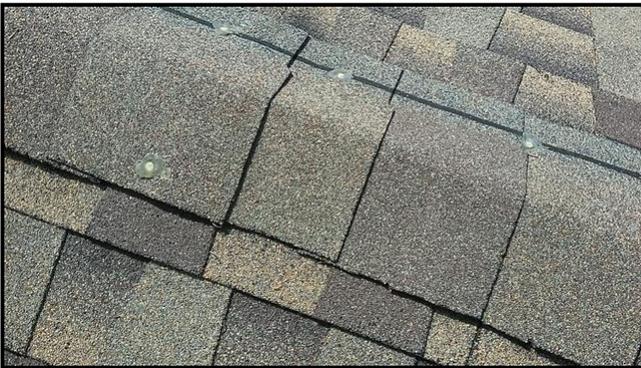
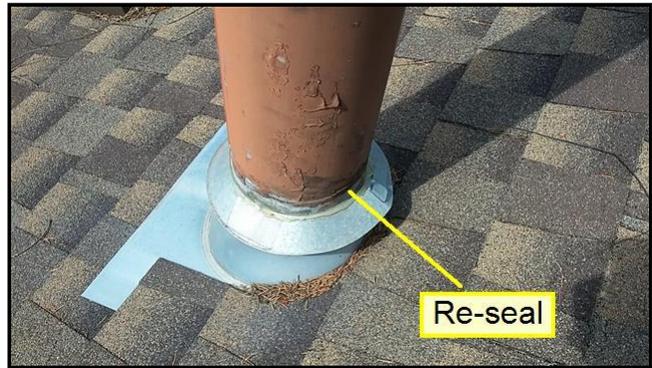
- Some roof sealant is drying out (at flue pipe and some nails). Recommend re-sealing this year before the winter.

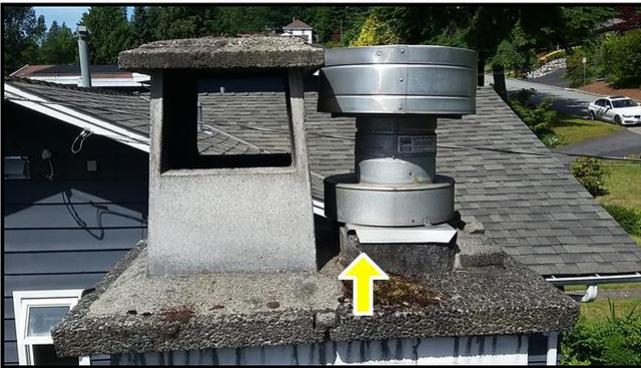
- The gas vent cap at the chimney (pictured) doesn't sit tight on the opening and may let water in. Recommend adjusting/sealing.

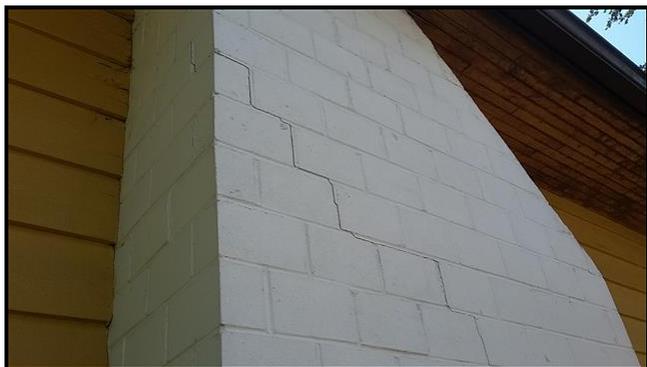
- There is some minor cracking at the chimney blocks however it appears stable. Recommend patching and monitoring for any further movement.

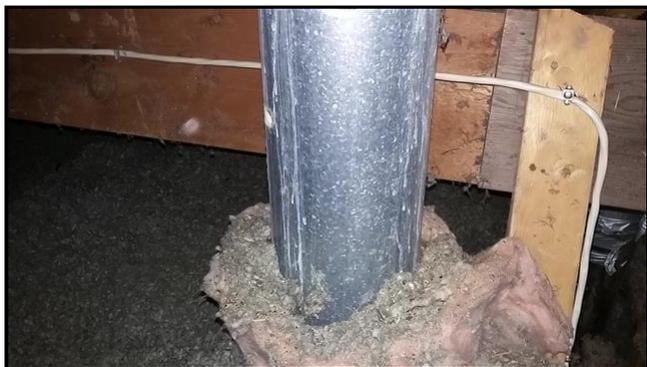
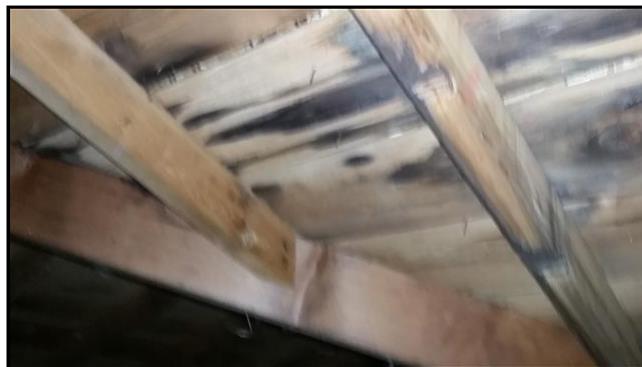
### 3.1 Roof Structure and Attic (Report leak signs or condensation)

- i** There are some old water stains in the attic which are likely from the previous roof. Recommend monitoring the attic during the next heavy rain.

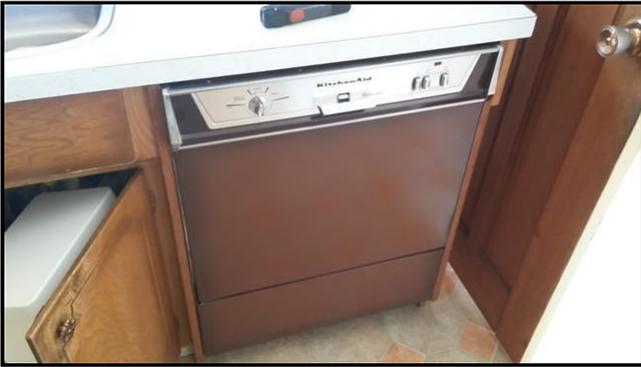
**4.4 Dishwasher**

The dishwasher is 48 years old and I did not test it. Recommend confirming operation prior to purchase.

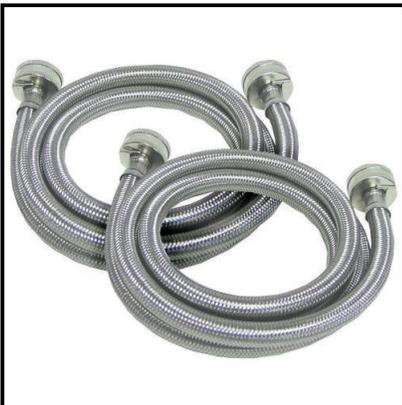
Maintenance Tip: Recommend the laundry hoses, toilet and sink supply lines be upgraded to a braided type. Standard rubber/metal flex hoses may burst and cause water damage.

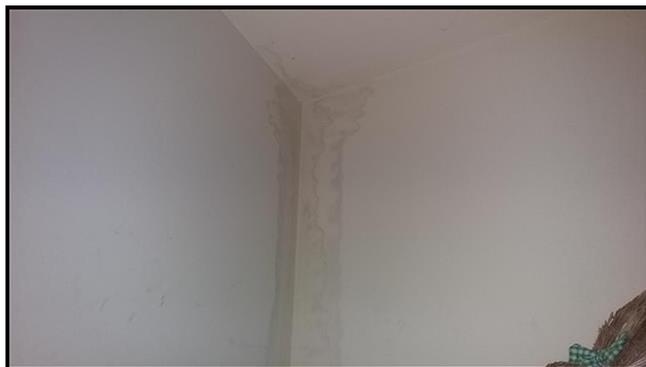
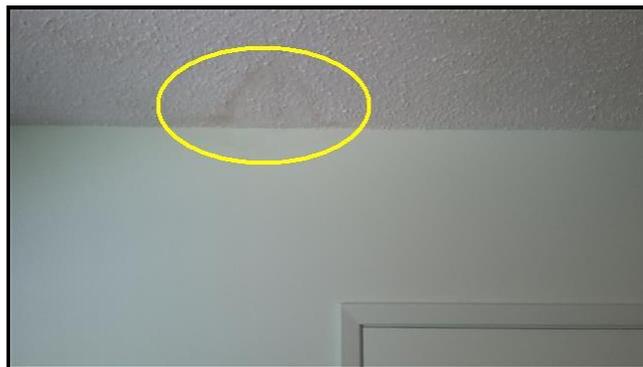
### 5.0 Ceilings

- i There is a moisture stain in the upstairs bedroom closet and ceiling. It was dry during inspection and may be from a past roof leak. Recommend painting and monitoring for any moisture in the future.

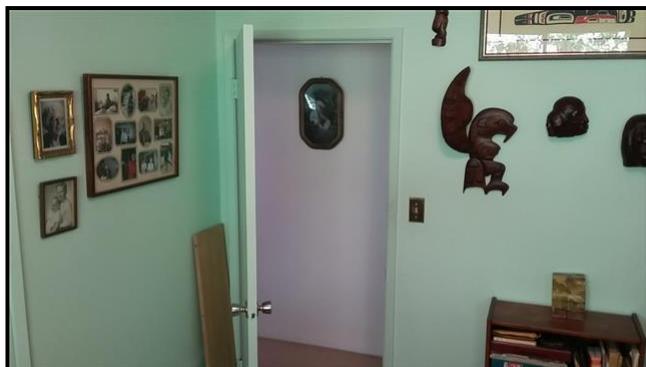
The second bedroom door was binding in the frame when tested.

Recommend having a contractor adjust or repair the door(s) as needed.

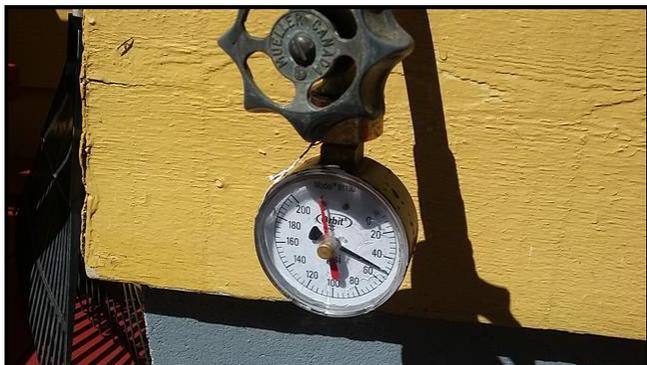
- i** The water pressure (measured at exterior) was 50 PSI. Ideal range is 40-70 PSI depending on municipality and size of home.

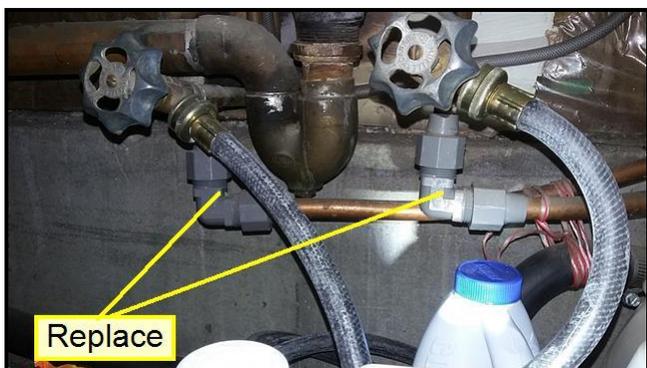
- i** Recommend replacing the plastic connectors below the kitchen and laundry sinks. Grey plastic (Polybutylene ) connectors have a tendency to leak.

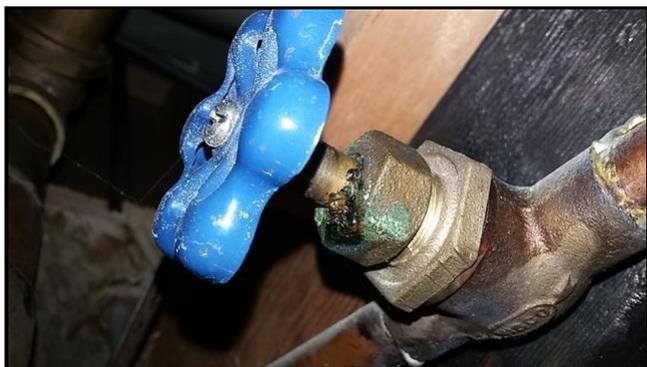
- w** Some valves in the basement ceiling were worn and dripping. Recommend replacing any failed valves.

3. Some valves in the basement ceiling were worn and dripping. Recommend replacing any failed valves.

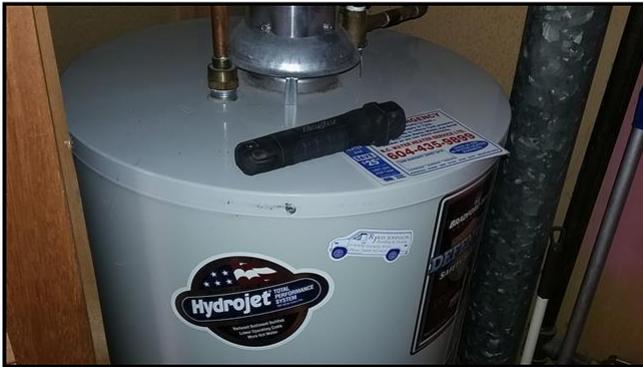
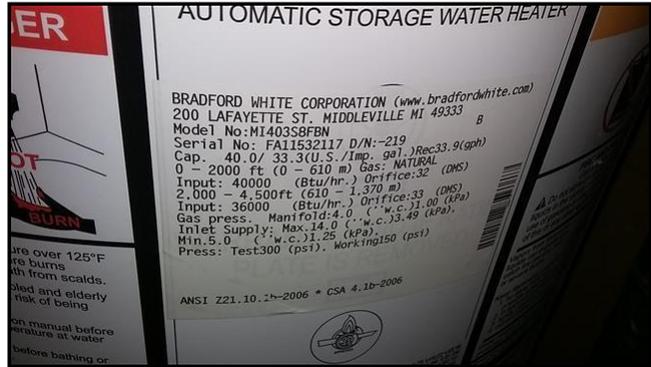
- i** The hot water tank was determined to be approximately 8 years old. Average service life on these tanks is 8-12 years.

Recommend installing a drain pan below the hot water tank to prevent floor damage in the event of a tank failure.

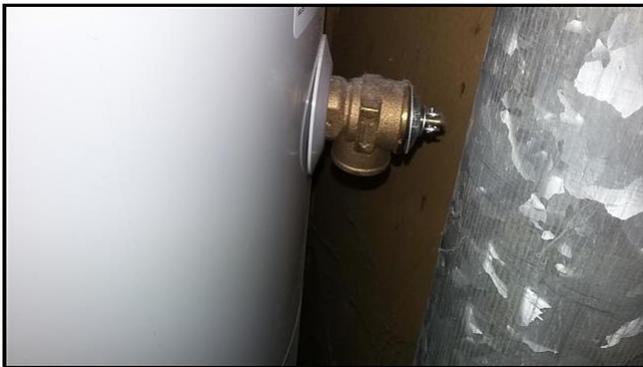
The T&P (Temperature and Pressure) relief valve on the water heater needs a 3/4 threaded pipe to extend within 6 inches of floor for safety. I recommend having one installed.

4. The T&P (Temperature and Pressure) relief valve on the water heater needs a 3/4 threaded pipe to extend within 6 inches of floor for safety. I recommend having one installed.

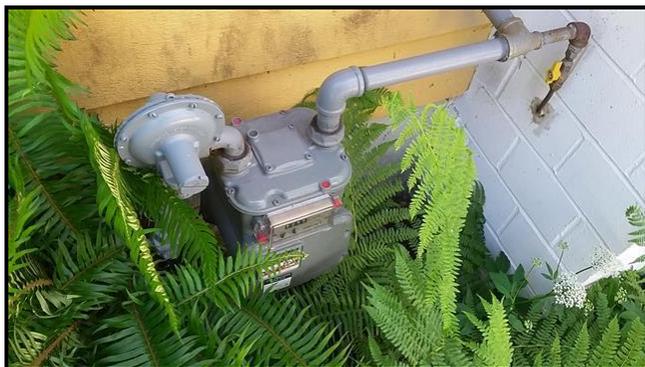
The main gas shut-off was located at the gas meter at the side of the home.

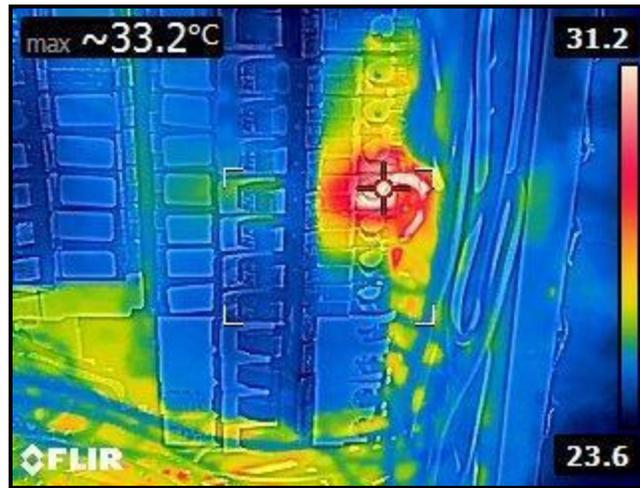
Thermal image of electrical panel

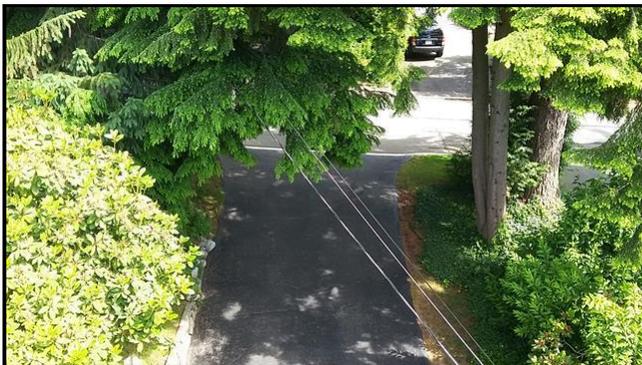
The overhead service conductors were in contact with the tree at the side of the home. The tree should be trimmed back, to avoid damage or collapse of the wiring.

This is usually done by contacting the utility company.

The overhead service conductors were in contact with the tree at the side of the home. The tree should be trimmed back, to avoid damage or collapse of the wiring.

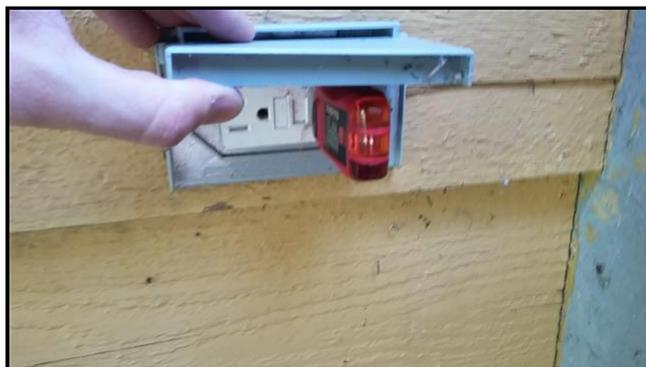
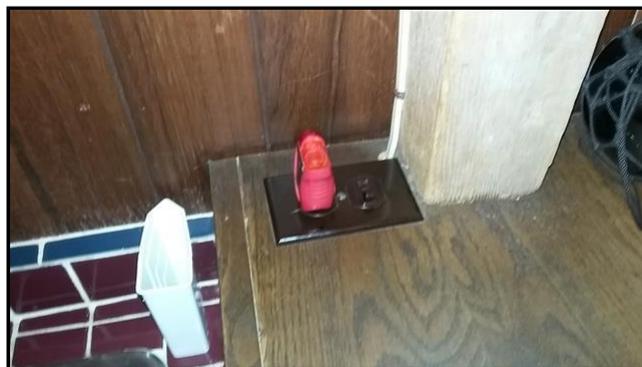
### 9.4 Connected Devices and Fixtures (Observed from a representative number operation of ceiling fans, lighting fixtures, switches and receptacles located inside the house, garage, and on the dwelling's exterior walls)

- w** One receptacle at the front exterior was not operational and needs replacement.

The receptacle at the wet bar was reverse-wired and needs re-wiring for safety.

One receptacle at the front exterior was not operational and needs replacement.

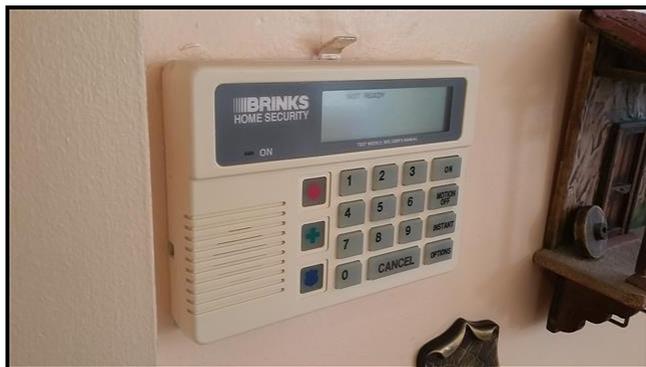
- i** Note: A security system was present, and appears to be energized, however was not tested. Client should confirm the security codes with the sellers. I was not able to determine if the system is monitored or if the equipment belongs to the owners.

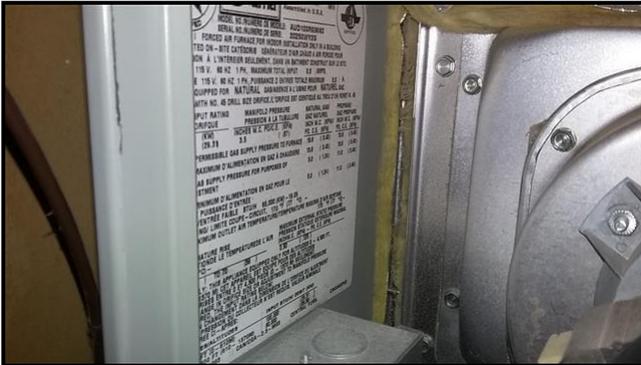
- The furnace was determined to be approximately 14 years old. Average service life for these units is about 25 years.

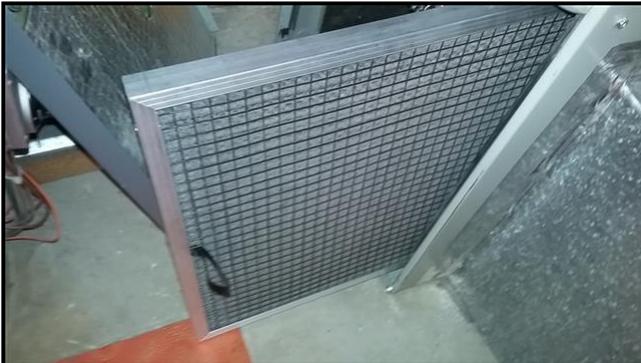
- The furnace filter is a washable type. Recommend cleaning to promote air flow and prolong the life of the furnace parts.

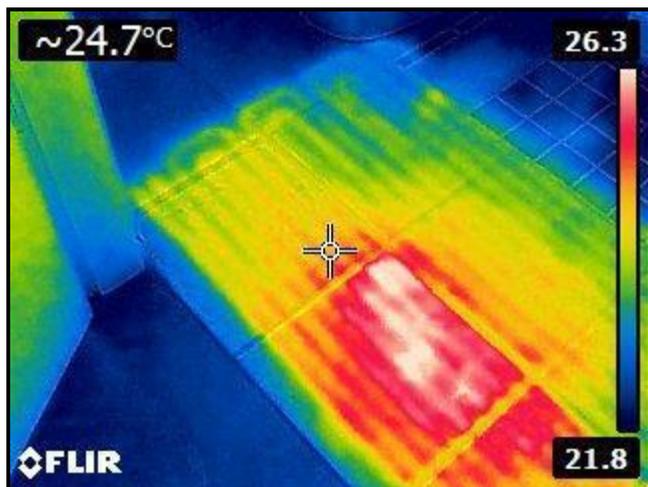
- Infrared: Confirmed operation of the in-floor heating system in the bathrooms.

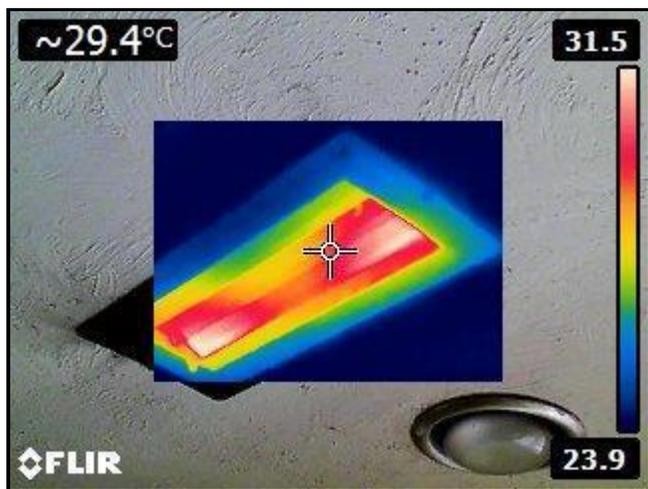
**i** Infrared: Confirmed heating system operation and heat at all registers.

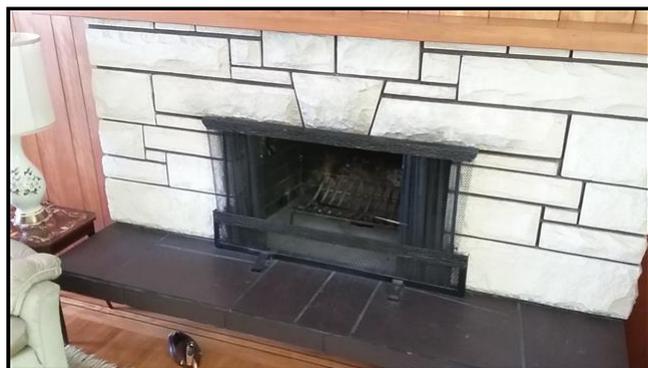
**i** There is one wood burning fireplace present. It appears functional however I recommend having a WETT (wood emissions transfer technology ) certified inspector service and test it prior to first use.
